PORTER-PARSONS FARM  
Worton, Maryland  
(early 19th century)

K-373

## INVENTORY FORM FOR STATE HISTORIC SITES SURVEY

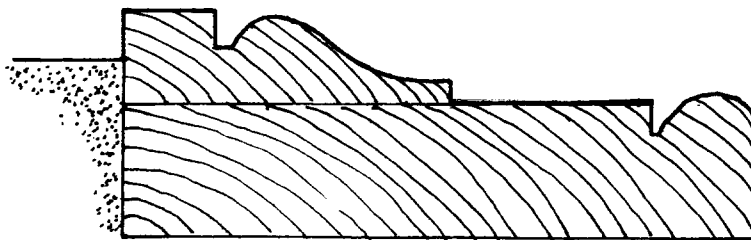
Trim-earlier section of house, interior, and exterior

Trim-later section of house, interior

Full Scale

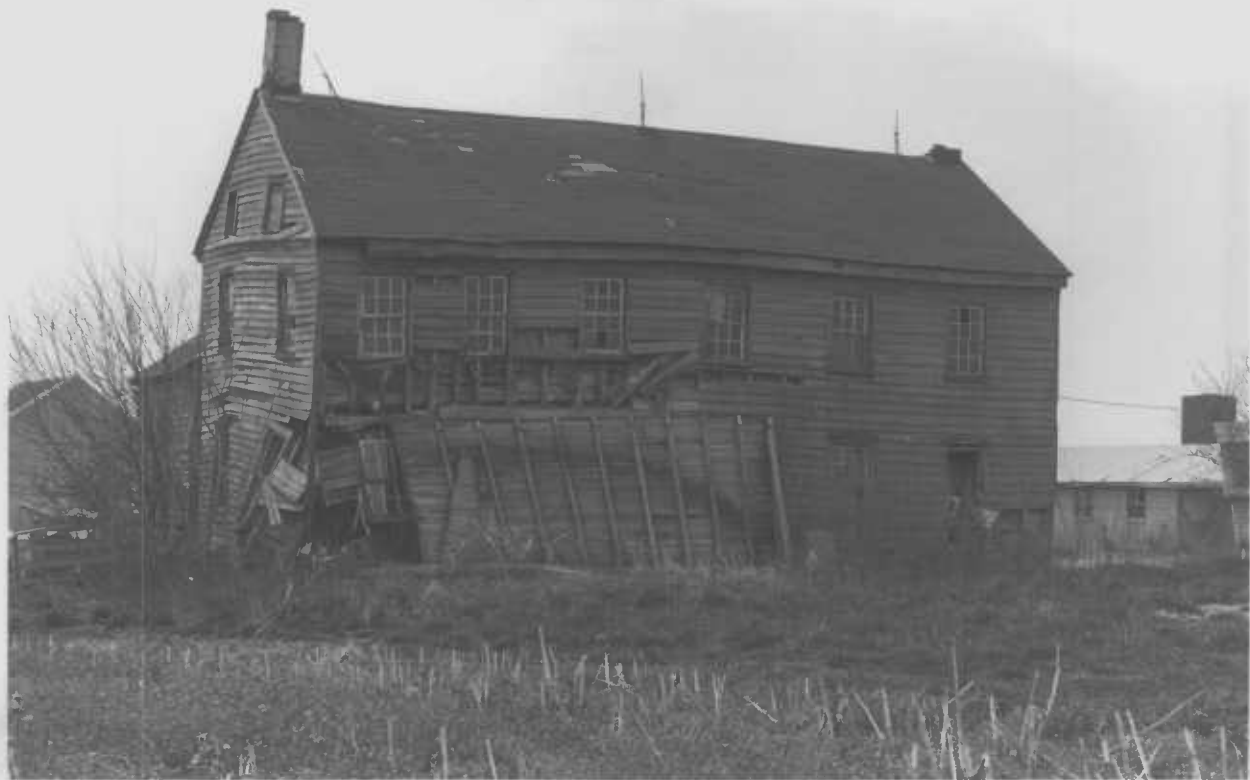
View to West

The Porter-Parsons house is a frame structure which is 6 bays long and two stories tall. It has a gable roof covered in asphalt shingles, and brick chimneys enclosed in each gable. That on the north has an exposed chimney back. The building is covered with lapped wooden siding and rests on a stone foundation. There is a true 1½ story gable-roofed addition on the south end of the rear wall, and remnants of a 4 bay, shed roofed porch on the front.

Windows have 6 over 6 sash and are evenly spaced in the 6 front bays and 2 end bays of the gable, although the earlier bays are the wider. Windows on the rear are opposite those on the front. There are also small square in the attic gables. What may have been a doorway on the east side of the north gable has been closed in. Window trim is plain in newer section, but in the earlier house it has an inside bead and a flat Grecian ogee backband. The roof cornice is unmolded and there are tapered verge boards in the gables; no detail of the porch is visible.

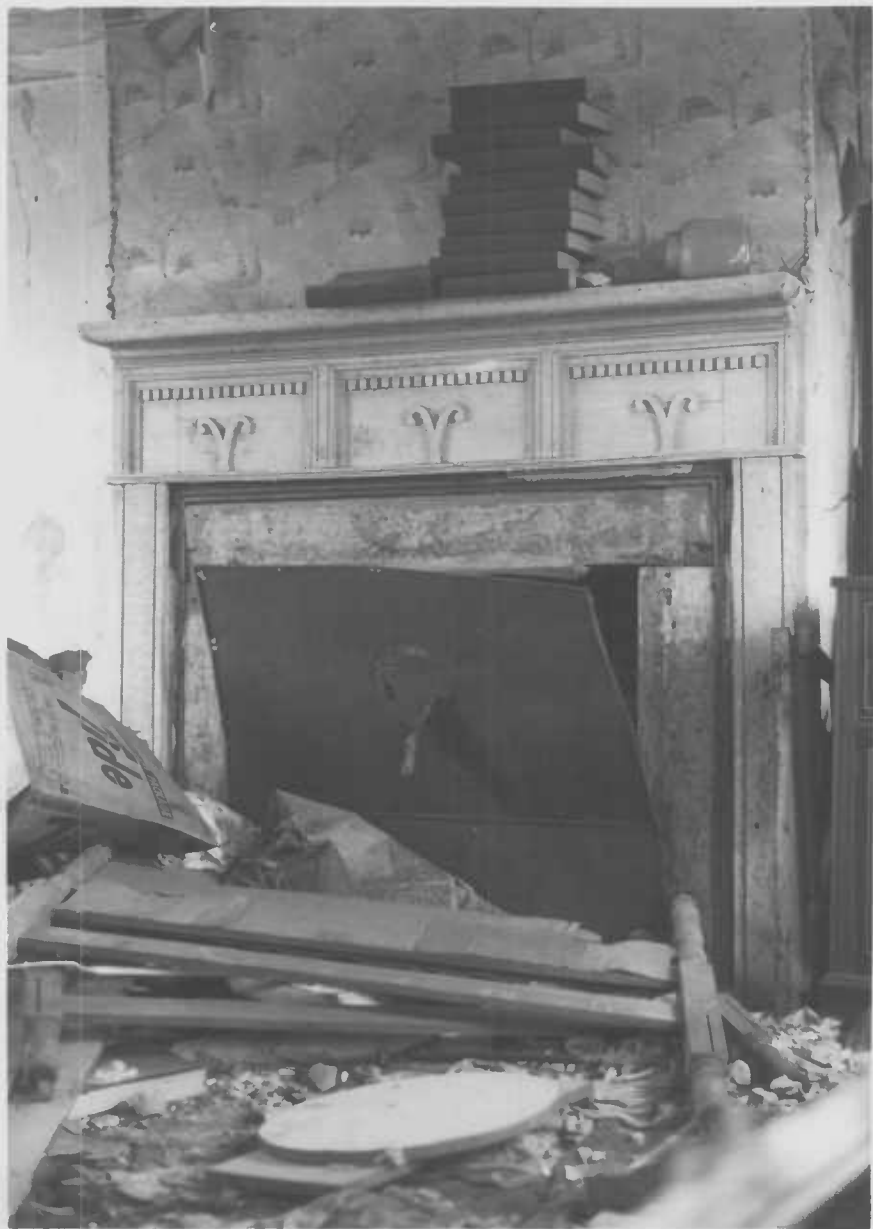
Parlor Mantel

The mantle in the parlour is the most interesting feature of the house. As shown in the photograph dentils and crude Y-shapes have been applied to plain recessed panels. In this room, the window and door trim, shown below, has only two coats of paint; the first is rust brown, the second medium grey. The walls, as elsewhere were whitewashed with later plaster. And the 5"-8" random yellow pine flooring was never varnished. A few rush matts remain on the floor. All of these finishes were typical of simple homes from the late 18th century until the early 20th.
